NEPONSET RIVER BASIN
WALPOLE, MASSACHUSETTS

BIRD POND DAM

MA. 00804

PHASE I INSPECTION REPORT
NATIONAL DAM INSPECTION PROGRAM

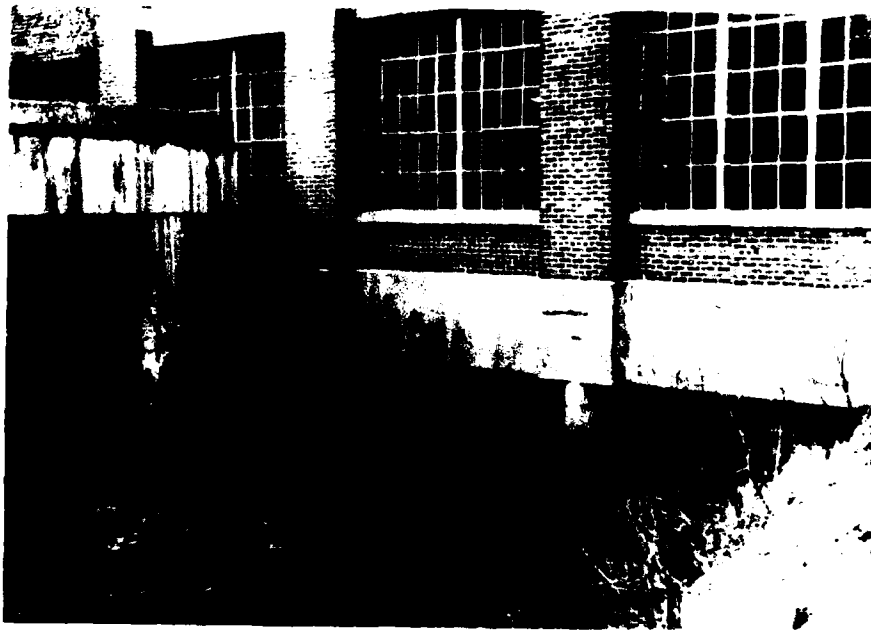
9. Culvert outlet about 300 ft. downstream of dam
